Erratic Sample Flow Case Study
Two Steam and Water Sample Systems
1789 MW Natural Gas Fired Combined Cycle - Two Power Blocks – “3 on 1”
Built: 2001-2003

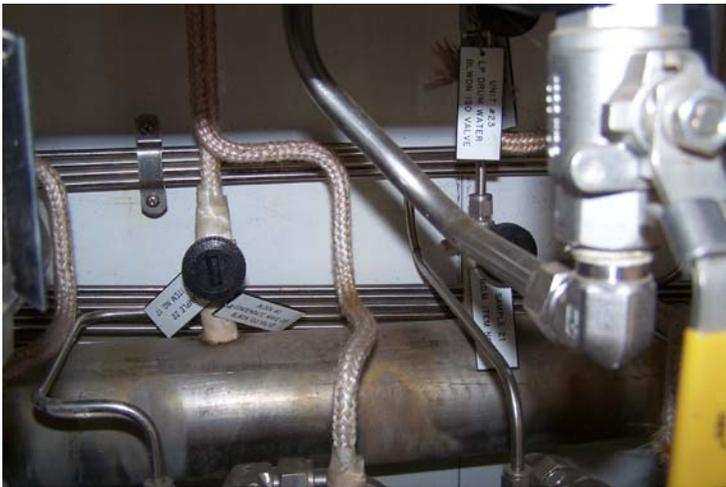
#1 – Blowdown Valves

Problem: The OEM blowdown valves were inadequate (black round handle **instrument type valves**– shown at left). The valves were located in a hard-to-reach areas and tended to leak due to frequent operation and plug and seat wire drawing/erosion from high pressure drops and two-phase flows.

Combined cycle units subject to daily load cycling tend to produce lots of magnetite and corrosion debris that demand daily blowoff of some samples, especially HP and IP Drum Water.

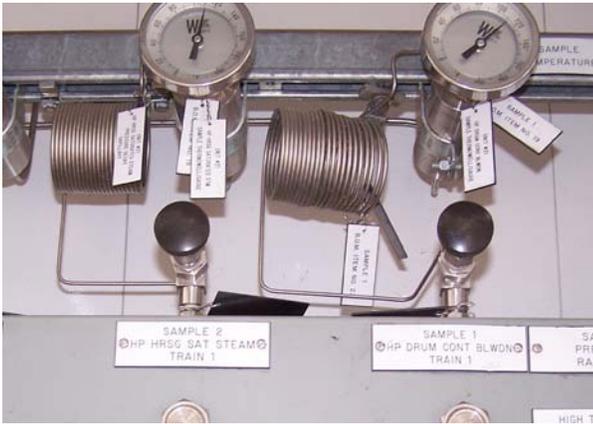
#2 – Flow Control/Pressure reduction

Problem: Coils of very small diameter **capillary tubing** were used as fixed pressure drop devices for the HP and IP Drum samples. These capillary devices plug with magnetite and debris, and are very difficult to clear.

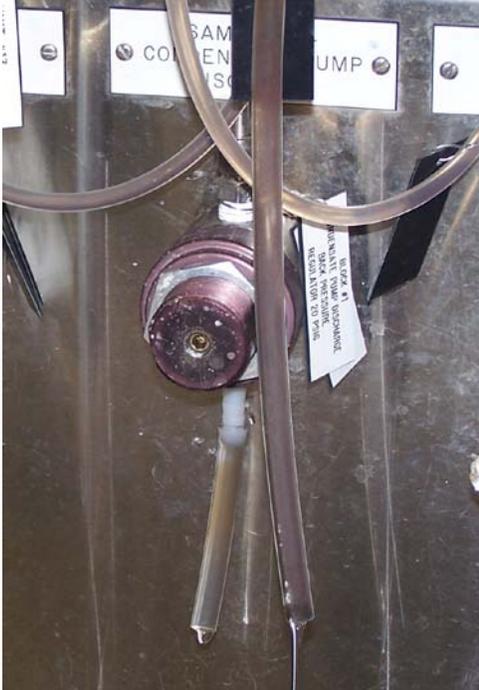
#3 – Back Pressure/Relief Valves

Problem: The OEM **back pressure/relief valves**, were not providing a “constant pressure header” to feed the analyzers. (Back pressure valves are shown at left, purple valve with hex nut. Note the lack of flow from the discharge tube, which was typical of all samples.) The valves were likely plugged with magnetite or other debris. The valves were tested and would not hold the back pressure steady and would not increase the discharge flow in response to increasing inlet pressure.

Functioning back pressure valves are essential to maintain a constant flow to all automatic analyzers.
